# SOME ISSUES RELATING TO THE MAN K8SZ 70/150 CLe NAVAL DIESEL ENGINE OPERATION

**Abstract:** *This paper presents the results of some tests of functional parameters of a naval propulsion engine. The checks were necessary to determine the accuracy of performance on board maintenance, including adjustment of the injection advance angles and cleaning of the exhaust gas spaces.*

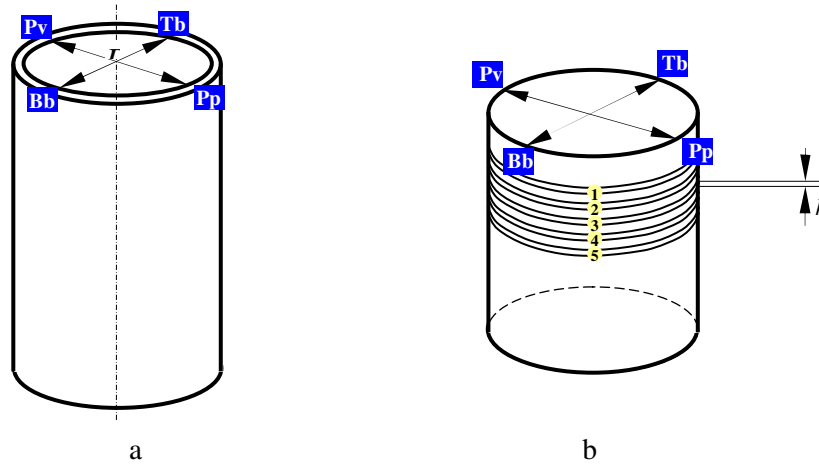
Further, after the cylinder mounting in the block, were performed measurements of the diameters. Determinations were made on two perpendicular directions (Pv-Pp and Bb-Tb), the corresponding position of the piston rings, in PMS (fig.1.a). Results are presented in Table 1 (first part).

Fig.1 Measurements made at the cylinder liner (a) and at the piston ring channels (b)

Before mounting, were cleaning the piston, the ring channels and the rings. Were conducted then measured at the ring channels on the piston and have obtained the values shown in Table 1 (second part).

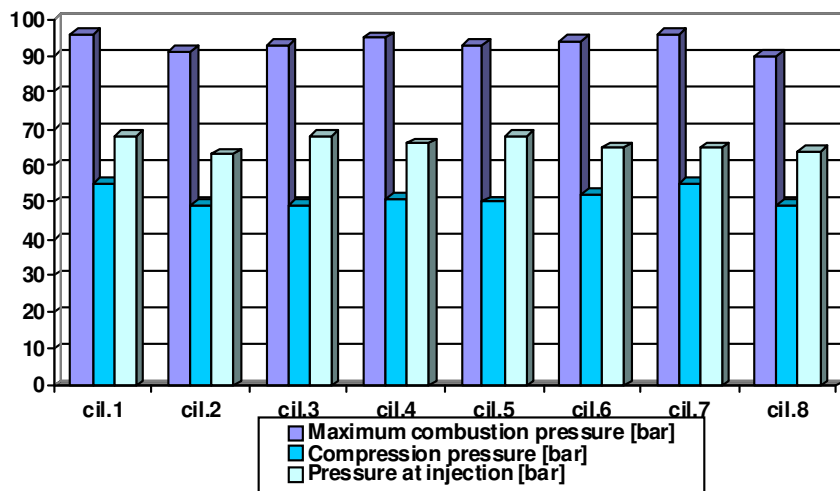
Measured values of the parameters are satisfactory, except for maximum combustion pressures that are too large. In order to reduce the maximum combustion pressure, was imposed the adjustment of the injection advance angles.

Fig.2. Values of functional parameters in the first determination ( $P_e=6184$  kW)

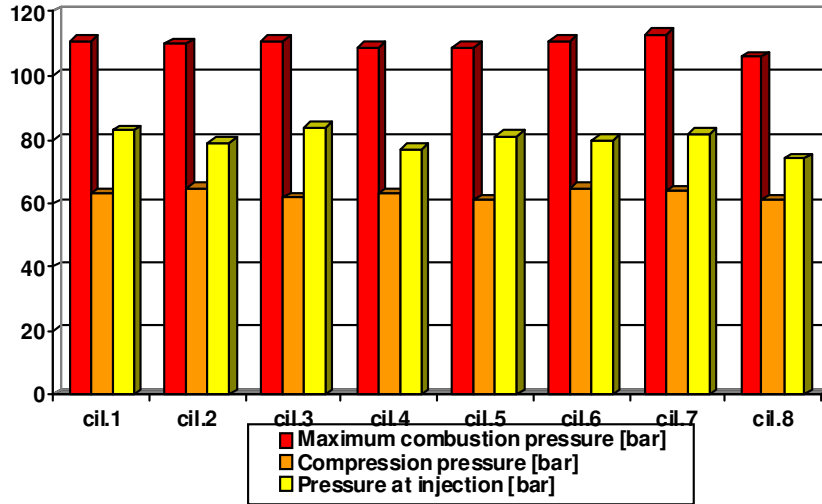
Fig.3. Values of functional parameters in the second determination (P<sub>e</sub>=9096 kW)

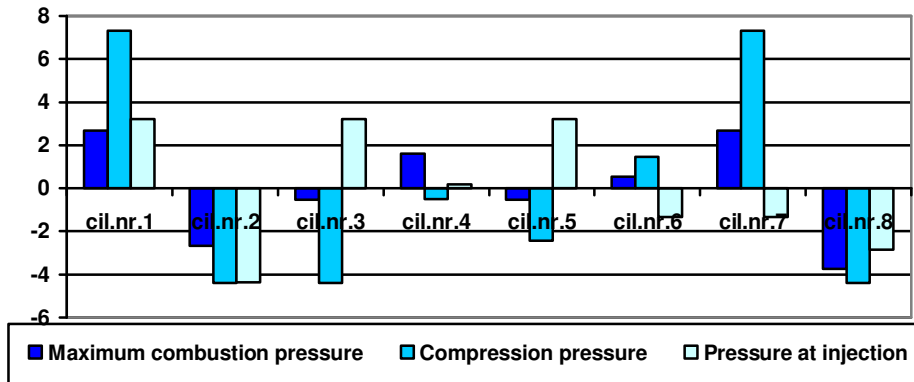
Fig.4. The dispersion of percentage deviations from some functional parameters in the first determination (P<sub>e</sub>=6184 kW)

For these parameters were determined the percentage deviations (Table 4), whose dispersions are shown in Figure 4 and 5.

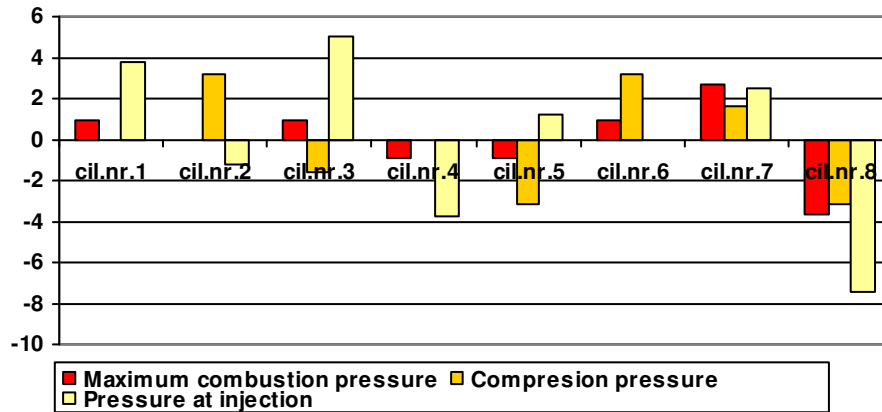
Fig.5. The dispersion of percentage deviations from some functional parameters in the second determination ( $P_e=9096$  kW)
