The 4th International Conference
"Advanced Composite Materials Engineering"
COMAT 2012
18- 20 October 2012, Brasov, Romania

**THEORETICAL AND EXPERIMENTAL CONTRIBUTIONS
REGARDING INFRARED THERMOGRAPHY EXAMINATION OF
COMPOSITE MATERIALS USED IN CIVIL AND INDUSTRIAL
CONSTRUCTION**

This paper presents a method of non-contact examination by infrared thermography for the determination of such defects in beams, fittings and embedded pipes.

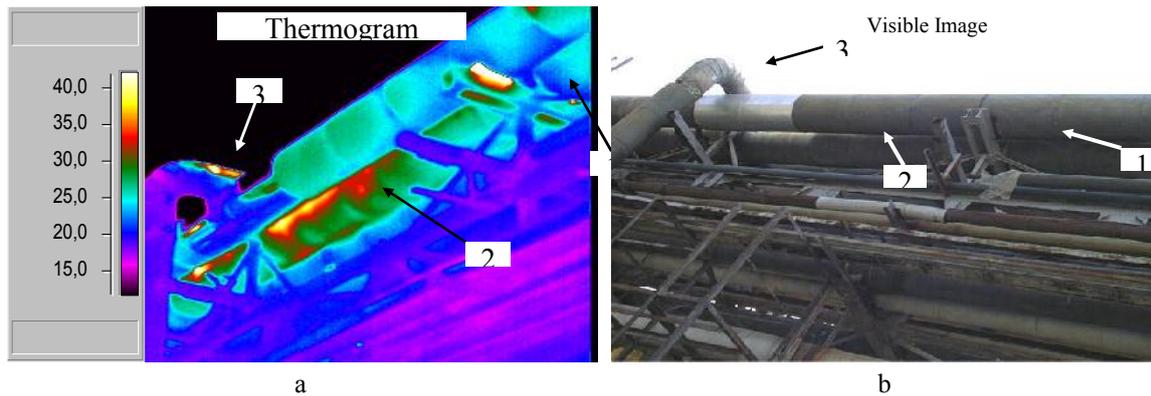
Figure 2 Highlighting modes of heat loss in pipe 6 daN/cm²:
a - thermogram, b - image visible:

1 - heat loss by conduction in the support base; 2 - degradation of insulation; 3 - sliding layer of mineral wool.

Shows the same infrared and visible images (for identification) of a portion of the steam pipeline at a pressure of 6 daN/cm².

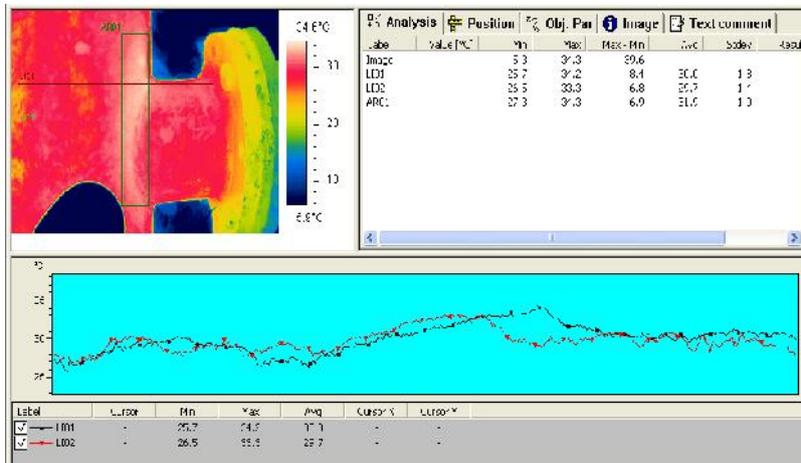
Figure 3. Thermographic image on the flow pipe at point T13

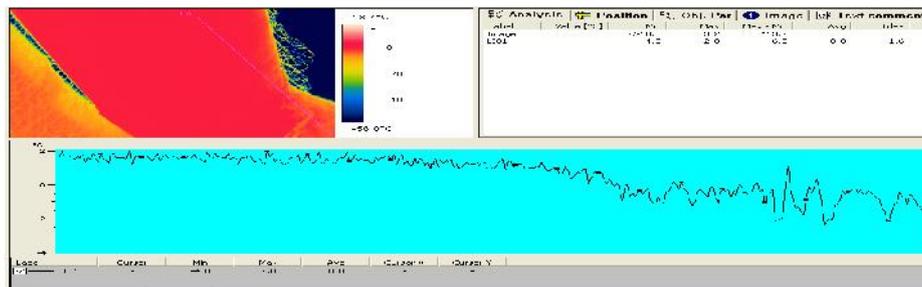
Figure 4. Thermographic image on the flow pipe at point T18

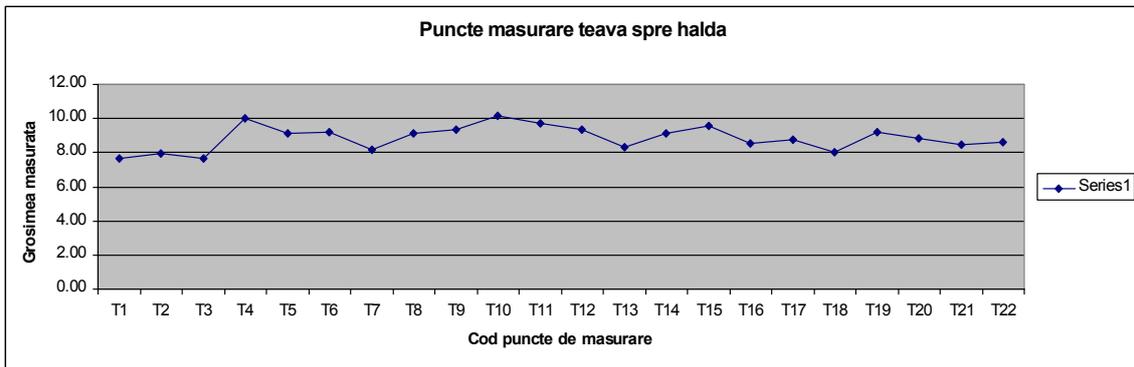
Thermograms obtained allowed the determination of pipe wall thickness measurement points as shown in figure 5, the pipe to the block of flats, in figure 6, and in figure 7, the return pipe.

Figure 5: Thickness variation pipe to block housing (pipe flow)

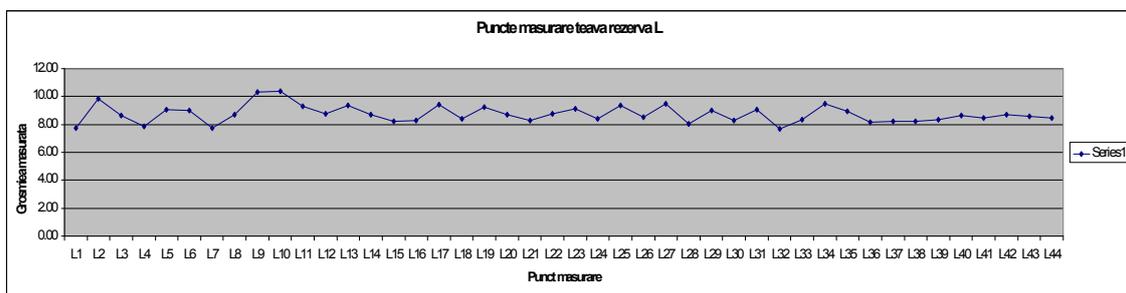
Figure 6: Pipe thickness variation up ltem no point

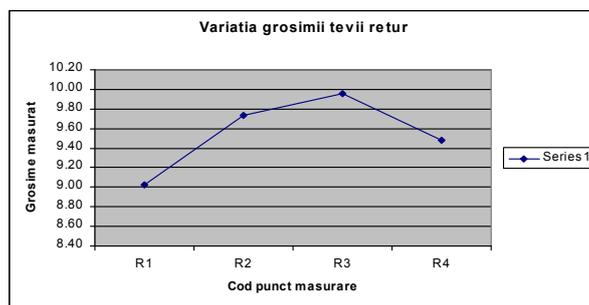
Figure 7: Return pipe thickness variation
