**ASPECTS REGARDING THE DEGRADATION OF A
RETAINING WALL WITH THE DESTINATION TO
REINFORCE THE STABILITY OF THE SITE
ARRANGEMENT OF RESIDENTIAL BUILDINGS**

I. TUNS and FLORIN-L. TAMAȘ

The paper presents situation generated by the execution of a section of domestic sewage, near and under the implantation foundation of a retaining wall having the role of maintaining stability of the arrangement site of residential buildings.

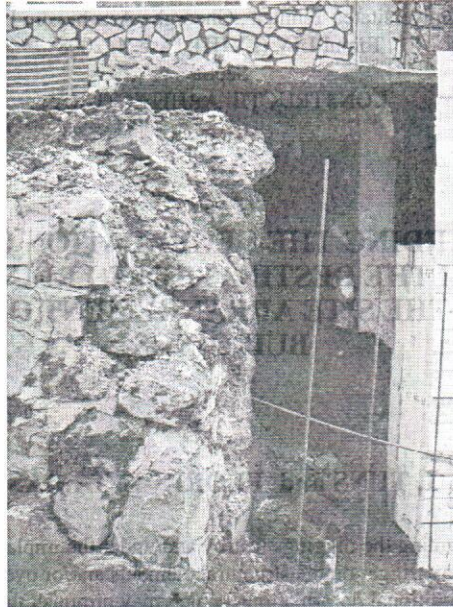
The analysed area is part of Cretaceous age, characterized by polymictic conglomerates that form the petrographic structure of the Mountains Poiana Brașov. The Morphology of the land plot shows that real estates are located on a platform artificially arranged, dug in a cenomanian conglomerate towards the Southern slope, a gritty powder diluvium to the North and behind the retaining wall an inhomogeneous stuffing layer made of scratchy rocks, sand and dust (Fig. 1).

Fig. 1. – Appearance of earth filling behind the retaining wall.

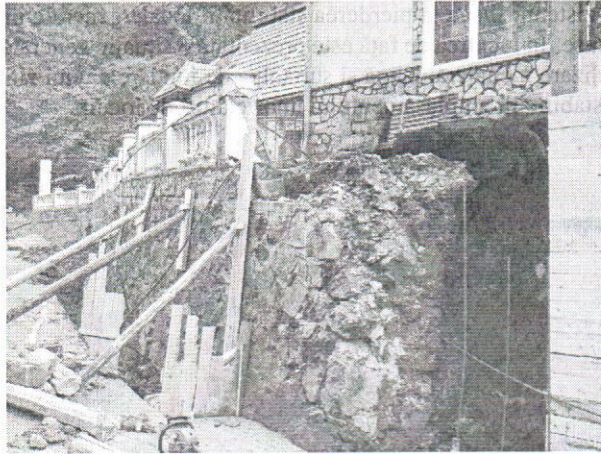
Fig. 8. – Blocking the movement of the retaining wall (using concrete works) and sustaining its wall parament.

a) blocking the movements of the wall base by casting of a stuffing concrete (C5/7.5) in the trenches made at its basis, while ensuring a support for the wall paramant [2] (Fig. 8);

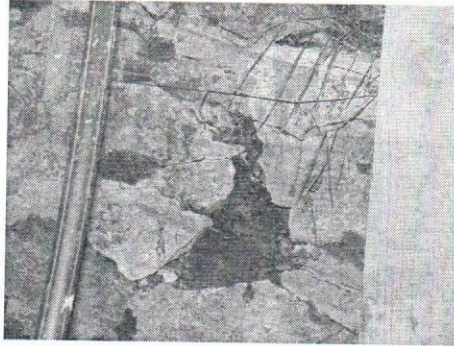
state of degradation, evidenced by cracks, exfoliations of material, by separation of the mortar from the joints and stones of the wall, enabling the development of vegetation (Fig. 7).

Fig. 7. – Portions of the wall with extended cracks, detachments of stone and abundant vegetation.

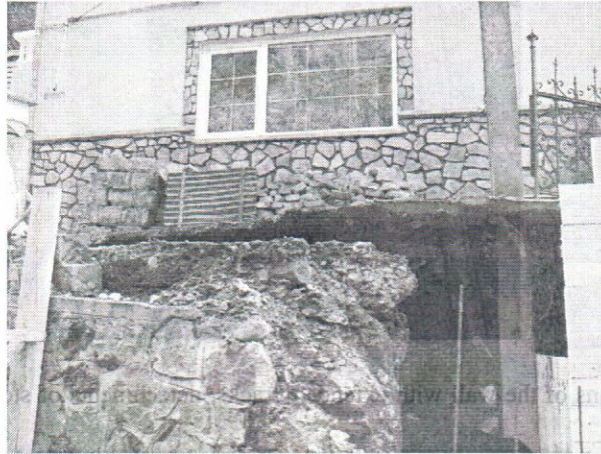
The linear and angular movements of the portion of the wall bounded by serious cracks have generated their separation from the wall and trigger of land portions expanding to the existing buildings (Figs. 5 and 6).

Fig. 5. – Portion of the wall detached from the wall.

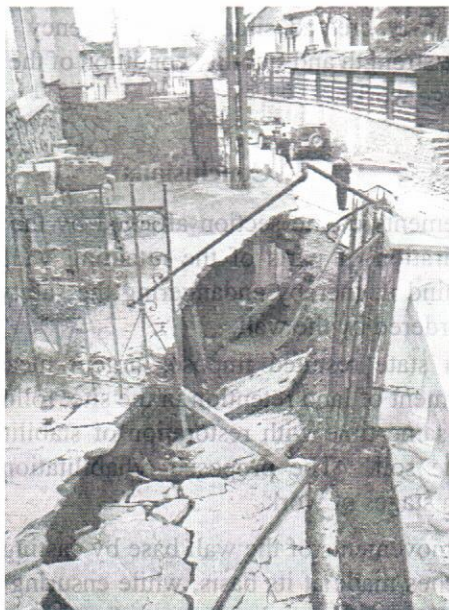
Fig. 6. – Crashing of portions of land behind the retaining wall.

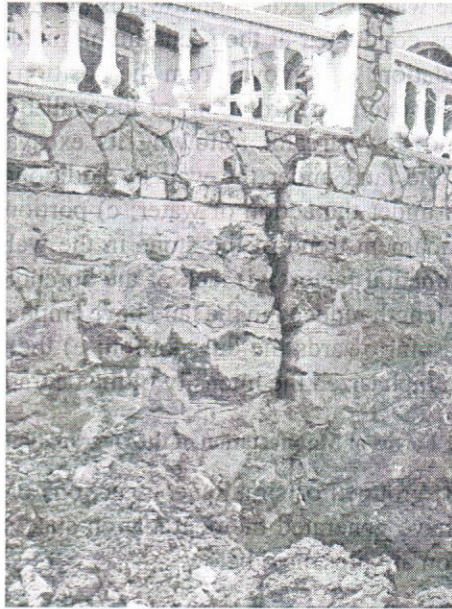
The opening of cracks formed in the area is accentuated in the area of the compression joint on the wall height, but cross also the support area of the protection bulwark achieved subsequently, (Figs. 3 and 4).

Fig. 3. – The large opening of the compression joint.

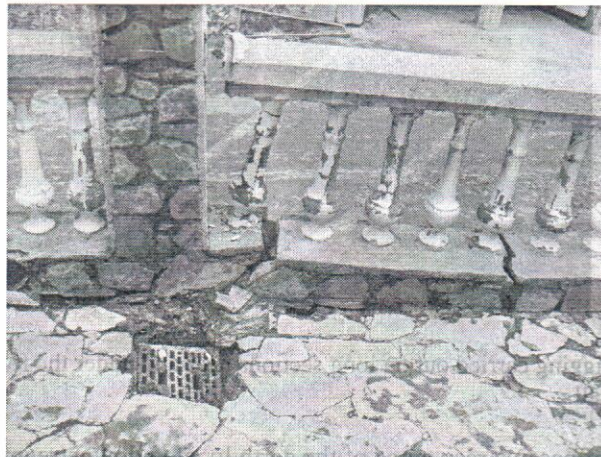
Fig. 4. – Cracks in the protection bulwark area.

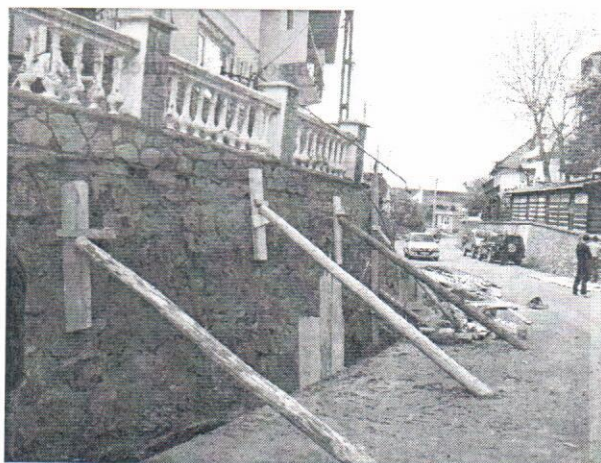
by cracks whose opening reaches to 10 cm.

Fig. 2. – The digging carried out on long sections near and under the foundation quota of the retaining wall.

The lack of passive resistance of the earth located downstream of the retaining wall [3], as a result of the digging carried out near and under the foundation quota, on long sections, (Fig. 2), led to linear and angular shifts of the wall, highlighted
