### METHODS FOR SLOPE PROTECTION AND STABILIZATION ON TRANSYLVANIAN MOTORWAY

**Abstract:** The paper presents some subject studies applied on 2B Section, Luna-Gilau, of Transilvania Motorway and includes stabilization methods for cut slopes. The soil conditions along the motorway are analyzed, likewise the causes leading to slope failures, as well as the reconstruction methods applied.

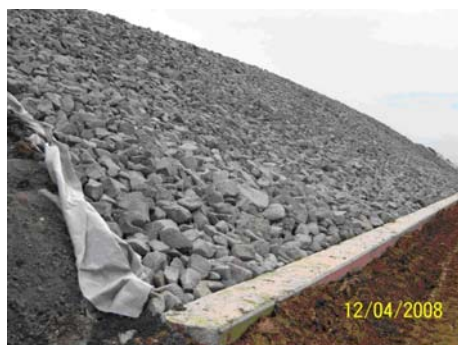
As a result and due to the fact that slope T1 has an eroded surface with small slope failures, it was decided to use drainage mask for slope stabilization and to remove all the damaged soil from its surface.

Fig.1 Slope stabilization with drainage mask km 35+160 – km 35+660

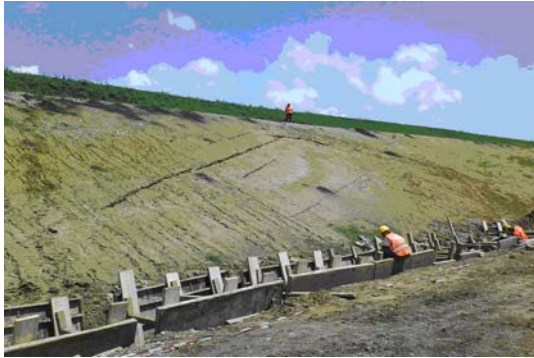
Between km 14+545 – km 14+580, a slope failure occurred on slope T1. This slope failure is of medium depth, and about 25, 00 m width, with a shape of cracks in different widths (0,10 – 1,00 m) and depths (about 2,5 m). The shape of the slope failure is not a classical one (circular) but it is, most probably, a plane surface of a layer. This is indicated by the position of the four cracks, parallel to the stratification.

The contractile clays have been affected by swelling and contractions causing cracks and fissures and leading to the loss of shear force. This failure seems to be mainly caused by the excavations at the toe of the slope performed for the longitudinal drain of the motorway. The excavations were executed during a highly humid period, with heavy rains and high temperatures. Therefore, the slope was reconstructed with joining steps and drainage fill, with one row of gabions at the toe of the slope.

Fig.2 Cracks that occurred during the excavation for the longitudinal drain

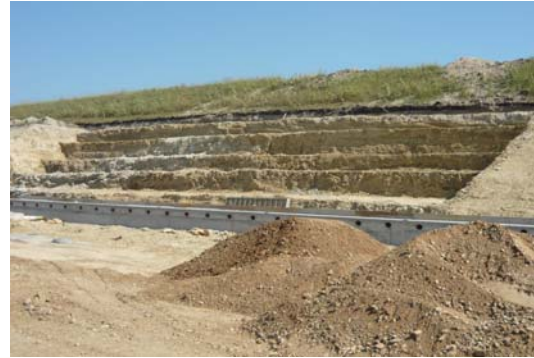
Fig.3 Slope excavation with joining steps

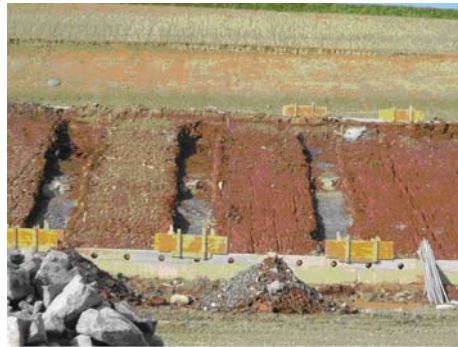
Due to the fact that slope T1, which is made of cohesive soils with water infiltrations, presents surface erosions and small slope failures on limited parts, execution of gridirons in the infiltration areas were recommended for impeding the weathering caused by the water.

Fig. 4 Slope stabilization with gridirons

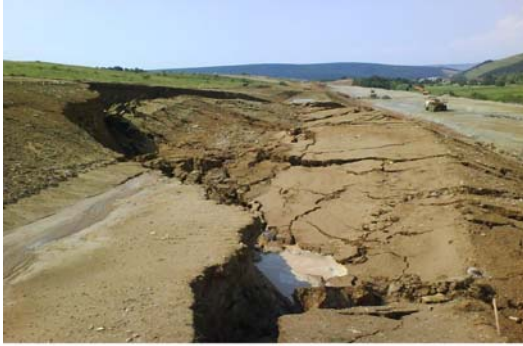
Between km 45+700 – km 45+780, slope T1 and T2, a slope failure of medium depth and about 75,00 m width occurred and developed mainly towards the upstream. The sliding plane has a classical circular shape; only in the upper part being concave. The physical-mechanical characteristics of the layers are presented in the bellow complex borehole profile:

The failures between km 45+700 – km 45+930, slope 1, were caused by: a period with high temperatures followed by torrential rains; heavy infiltration in the upstream part of the slope; presence of clays sensitive to temperature and humidity changes in a cohesive low mass and permeable material; alternation between cohesive and non-cohesive deposits oriented towards downstream and, thus creating a wide range of sliding plans because of the infiltrations.

Fig.5 Sliding km 45+700 – km 45+780

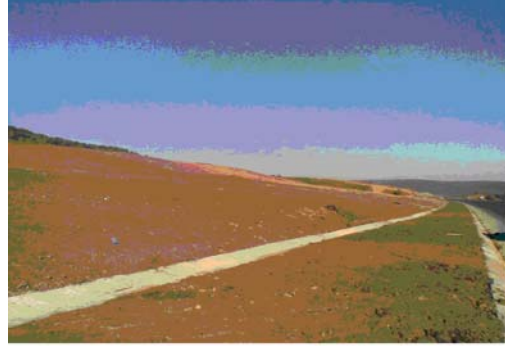
Fig.6 Laying back slope to 1H: 6V gradient
