SCENARIO OF FRACTURE DEVELOPMENT IN BUCKET WHEEL EXCAVATOR

Darko Daničić¹, Stojan Sedmak², Ivo Blačić³

2. FAILURE OF A BUCKET WHEEL EXCAVATOR

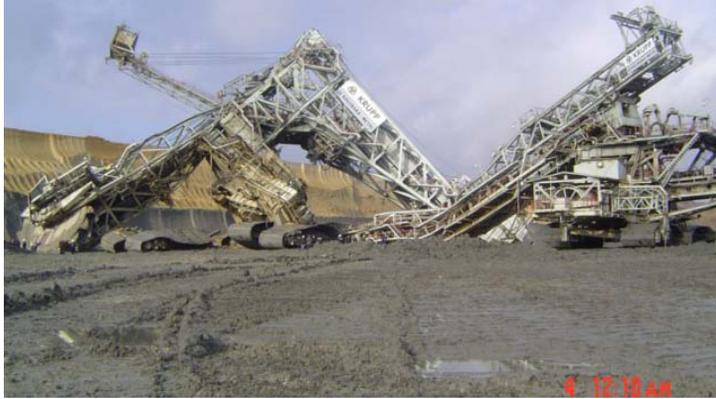
BWE SchRs 1760, unexpectedly and with no warning catastrophically failed in 2004, after 17 years of regular service, on an open surface mine in Serbia (Fig. 1). Fatigue fracture, initiated in welded joint and developed in lugs of counterweight holder (Figs. 2, 3), followed by final fast fracture, had been the cause. Cracks initiated in the sites of stress concentration and inhomogeneous microstructure of welded joints, primarily in HAZ, under the effect of external loads and residual stresses /13/.

Figure 1. Collapse of bucket wheel excavator SRs 1760

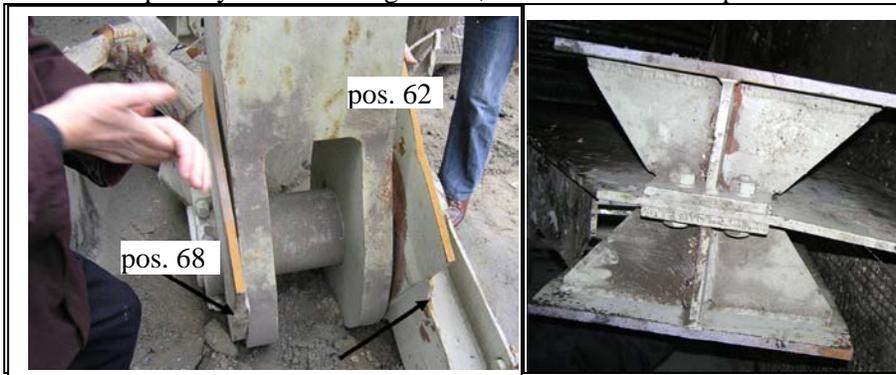
Figure 2. Fracture of two lugs on counterweight holder

Analyzing the lugs in Fig. 2 and design scheme (Fig. 5.a) a symmetrical distribution of load and stress in two lugs could be assumed as reasonable. This was not the case, as it is possible to conclude analyzing the fracture surfaces on lugs 62 and 68 (Fig. 3).

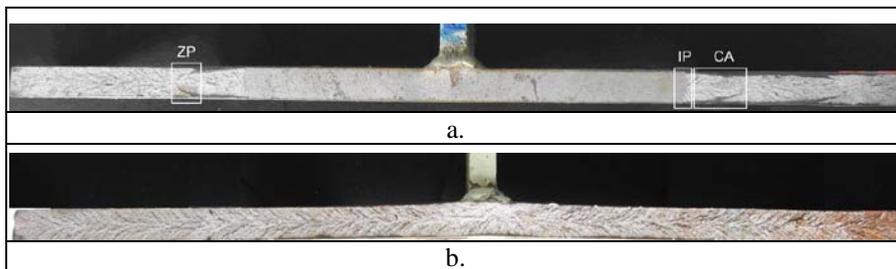
The fracture surfaces of left lug, pos. 68 (Fig. 3.a) and right lug, pos. 62 (Fig. 3.b) are substantially different. Right lug fractured in brittle manner, due to an overloading. Brute fracture in left lug took place when the loaded cross section area was significantly reduced after extended fatigue cracks on both sides of welded rib (Fig. 3). Flat fatigue crack growth in pos. 68 had been interrupted by stable crack growths, with visible shear lips.

Figure 3.a. Lug (pos. 68) fracture (fatigue, stable crack growth and brute fracture)
 b. Brittle fracture of lug (pos. 62), indicating single initiation point from both sites

The examination of the fracture surface of the position 62 showed the chevron pattern indicating that the fracture started in the weld metal, in the area between the two passes, Fig. 3.10. Generally, the occurrence of the unstable crack growth is typical for all the constituents of the welded joint and the parent material. Since no cracks have been arrested during the fracture of the position 62, one can say that, based on Pellini's analysis /16/, the stress applied in the cross section was above $\frac{1}{2} R_{p0.2}$. This fracture has another typical characteristic: there are no shear lips on the fracture surface.

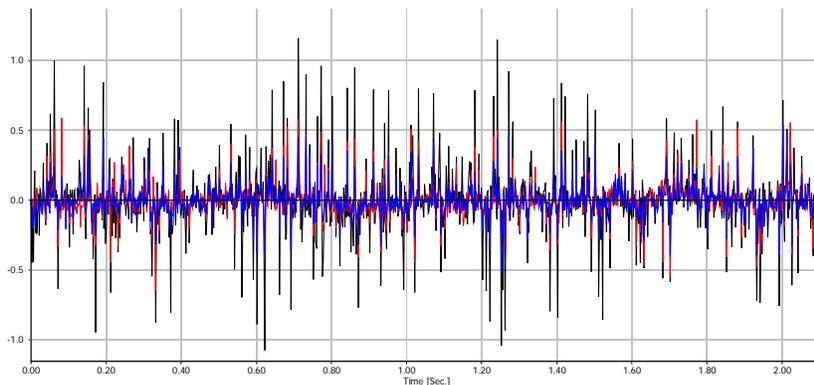
Figure 4. Strains recorded in typical locations of BWE welded structure in operation

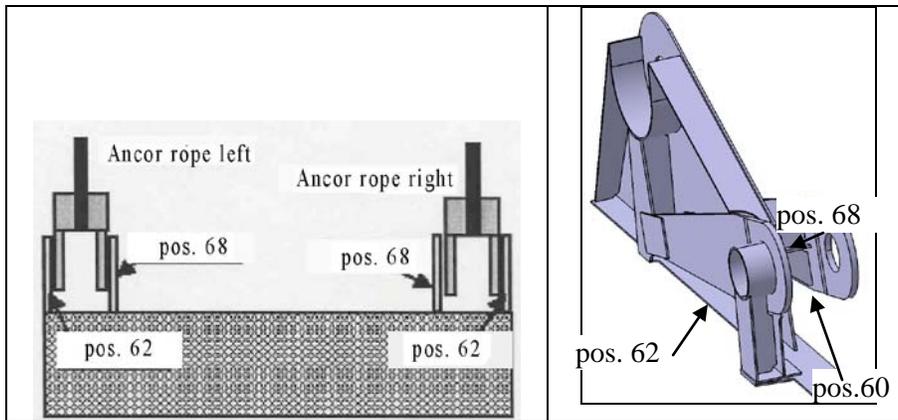
Figure 5.a. Design scheme of anchor ropes. b. Presentation of connection of the main rope and a structure of the counterweight

In the case of BWE SchRs 1760, originally applied design of connection of the main rope to counterweight structure had more than one unfavorable solution. Double lugs design is used (Fig. 5) and the load distribution in structure is non symmetric regarding direction of the load. From Fig. 5.b it is clear that the tension force is transferred to the positions 62 and 68 through the ribs, pos. 60. In this way the distribution of load to the lugs is unbalanced. Ribs, although transferred the load, were treated as auxiliary elements and strict requirement for welding inspection was not prescribed.

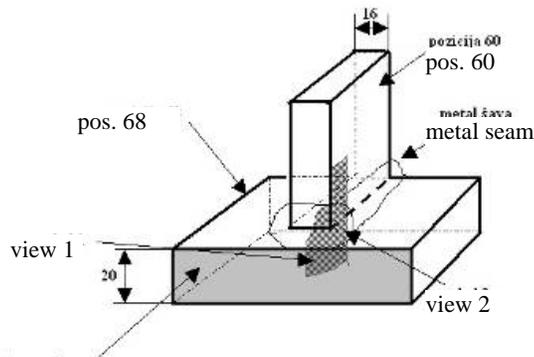
The design details of welded joint between rib (pos. 60) and the lug (pos. 68) are shown in Fig. 6. The same design is used for other lug, pos. 62.

Figure 6. Design scheme of welded joint between lug (pos. 68) and rib (pos. 60)

The design details (Fig. 6) indicate that fillet welds applied between rib (pos. 60) and the lug (pos. 68) had been performed without penetration, since the joint had been considered as an auxiliary one. These welded joints had not been manufactured according to welding procedure specification (WPS) and were not inspected properly. Heterogeneous microstructure (Fig. 8), and presence of defects and imperfections, (Fig. 9), discovered by investigation after collapse, are typical.

Fracture initiated from cracks in critical welded joint. The problem would not appear if this welded joint is not introduced in a structure of the counterweight. It is likely that, after experience with BWE failure, the design solution without welded joint of that kind is possible.

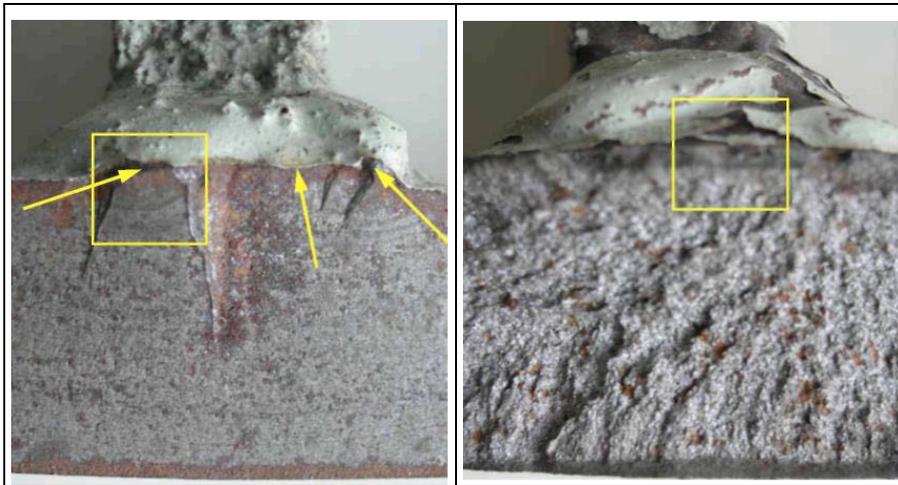
Two facts have to be noticed. At first, the fatigue crack started from welded joint between the positions 68 and 60 (Fig. 7 left), on the defect location 1, produced by welding. Variable loading had been transferred as fatigue loading completely to position 68 (Fig. 3.a). On the other side, on the position 62, although similar defects had been detected (Fig.7 right), fatigue crack did not developed (Fig. 3.b). The explanation can be found in the design of the lugs: position 62 is fixed to the main structure (Fig. 5.b) while position 68 is free to swing.

Figure 7. Welded joints between rib and lugs (pos. 68, left, pos. 62 right)

Figures 7 to 9 allow to conclude that for both lugs the welding quality is poor, causing eventually the high level of stress concentration, similar in joints of both lugs, pos. 68 and 62. to the ribs.

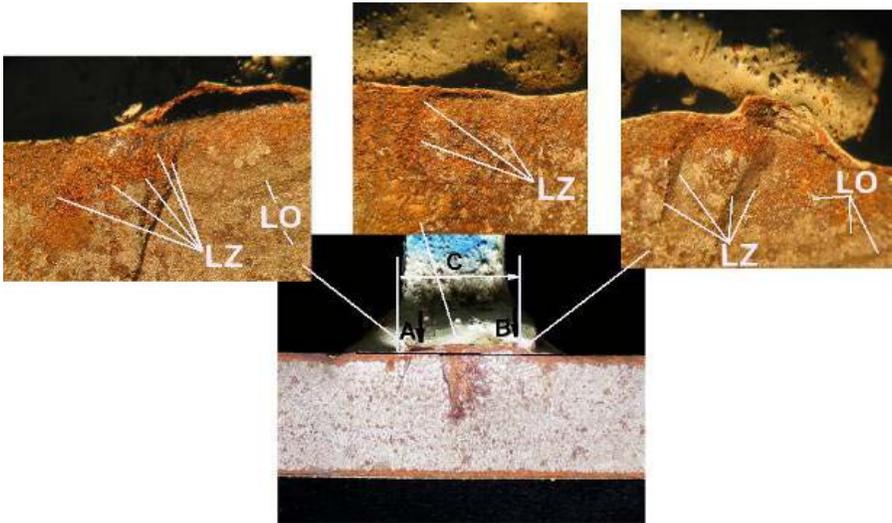
In BWE welded structure with defects (Fig. 7 and Fig. 9), and inevitably heterogeneous microstructure (Fig. 8), exposed to load characterized by maximum initial static value and operational variable load, crack might be locally initiated by brittle fracture in microstructural region of low fracture toughness, by combined low cycle fatigue and crack tip blunting followed by stable crack growth in the more ductile region or by high cycle fatigue due to variable loading. Since the change in microstructure is sharp, crack initiation can include in both lugs all three, brittle, ductile and fatigue cracks, Fig. 7. The stress concentration, constraint and residual stresses, in addition to the variation of mechanical properties due microstructural heterogeneity can govern the mode of crack growth. Interrelation between influencing factor is decisive for the dominant type of a crack, but the fatigue crack will be surely present at the transition of welded joint to a lug, as can be concluded from Fig. 10.

Figure 10. Initiation of dominant fatigue cracks in lug, pos. 68: details in locations A and B, LZ- ratchet marks, LO- beach marks, critical region C

For the scenario of fracture in Fig. 3.a more interesting is development of fatigue fracture in lug, pos. 68. More details about fatigue crack transition to the lug, pos. 68, are visible in Fig. 10. They might be used in explanation of fatigue crack initiation in this lug. Variable loading exerted its effect only to pos. 68, and not in pos. 62, what is attributed to fixation of the later to main structure.

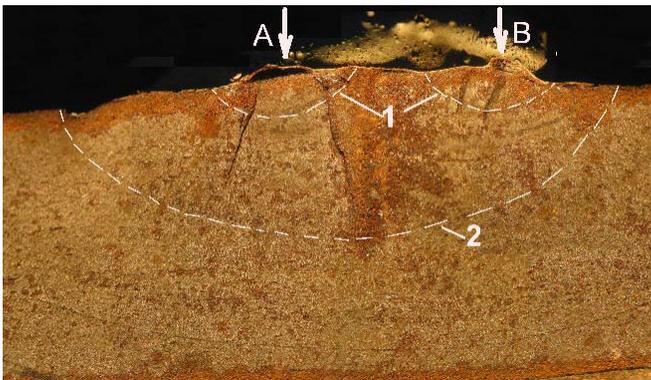
Ratchet marks, beach marks and striations, as typical for fatigue, can be recognized on fracture surface (Figs. 7 and 10), which entered in lug as two separated fatigue cracks 1 in an early step and merged in a dominant fatigue crack 2 (Fig. 11). It is interesting to note that cracks 1 started in the HAZ of low fracture toughness in lug material, and crack 2 developed through the material of more homogeneous microstructure of parent metal.

Figure 11. Merged early fatigue cracks 1, points A and B, in a dominant crack 2

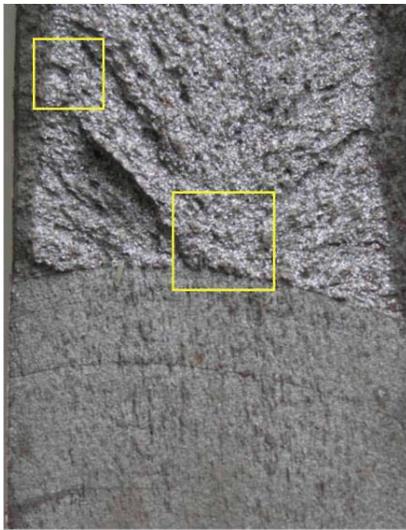
Increasing fatigue crack continually reduced bearing cross section area of the lug, pos.68, to a size critical for fast fracture. It is reasonably to assume that fatigue crack grew uniformly from crack 2, according to applied load, Figs. 3.a and 10, on both sides of welded joint, Fig. 7 left. Applied variable stress increased by increasing fatigue crack, due to continuously reduced bearing cross section area. This allowed fracture mode transformation from high to low cycle fatigue first, as shown in region IP and in magnified view in Fig. 12.

Figure 12. Transition from flat fatigue fracture surface, with visible beach marks and less visible striation, to stable tearing, region IP in Fig. 3

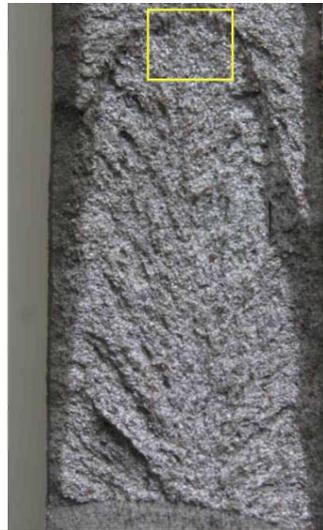
Figure13. Final stretch zone after developed shear lips prior the next stable growth of ductile crack, corresponding to region CA in Fig. 3

After stress redistribution, fatigue crack continued to grow continuously, by low cycle process beyond final stretch at CA and by high cycle process on the other side, up to simultaneous transition to tearing mode on both sides. Fracture process ended by fast fracture on both ends, after probably simultaneous development of final stretch zones (FSZ).

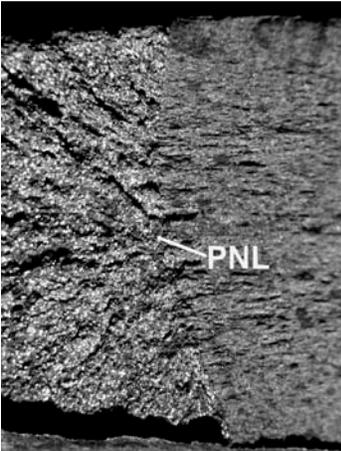
The region of transition from fatigue into static fracture is presented in Fig. 14. In addition to beach marks, static splitting fracture had been detected in the fatigue process, in crack tip blunting region, where structure with low cohesive strength are present along the plate thickness. The presence of static fractures on the fatigue fracture surface indicates the faster rate of propagation of the fatigue crack.

Figure 14. Transition from fatigue to static fracture, PNL- final stretch zone

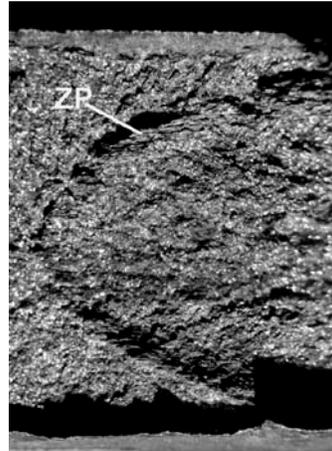
The presence of chevron patterns in the static fracture portion indicates the initiation of unstable growth, in the middle of plate thickness where plane strain condition dominated. Partial crack arrest (Fig. 15), along with unstable fracture, indicated that the fracture occurred above nil-ductility transition temperature (NDTT), in the brittle range. According to Pellini /16/, a material can arrest the crack only if the applied stress is lower than $\frac{1}{2} R_{p0.2}$. In this case, this is 185 MPa, well below allowed operating stress.

Figure15. Crack arrest zone, ZP – crack arrest
