SEISMIC STRENGTHENING OF A PRECAST REINFORCED CONCRETE WALL PANEL USING NSM-CFRP

Abstract: *The precast reinforced concrete wall panel (PRCWP) presented in this paper is part of an experimental program in which the seismic performance, weakening effects due to cut-outs, strengthening strategies and cost evaluations were investigated. The experimental specimens were 1:1.2 scaled RC as-built solid walls or as-built walls with window or door openings. The specimens were subjected to cyclic load reversals, displacement controlled. Most of the specimens were first tested unstrengthened, then after they were repaired, strengthened using FRPs and tested again. The wall panel presented here was post-damage strengthened using near surface mounted (NSM) carbon fibre reinforced polymers (CFRP). The repair and strengthening strategy steps will be presented together with the experimental results of both the unstrengthened and the post-damage strengthened specimen.*

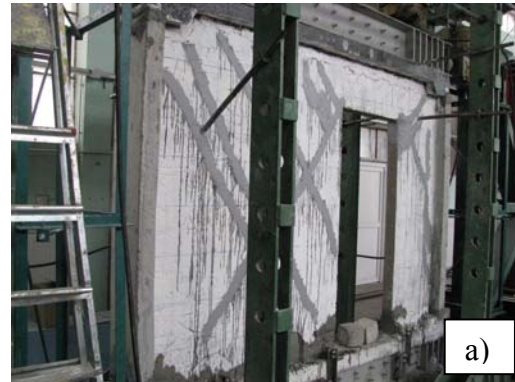
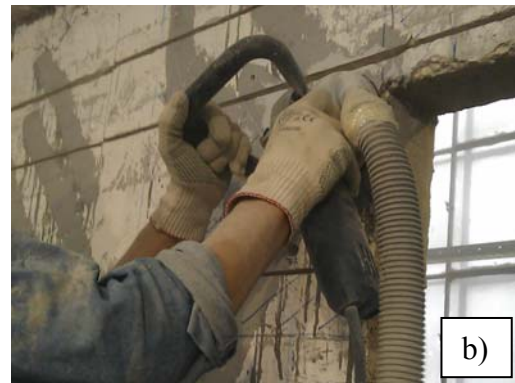
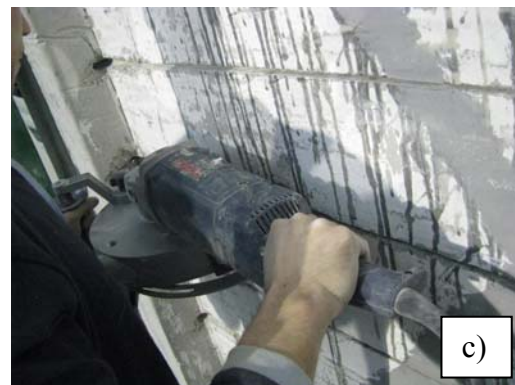
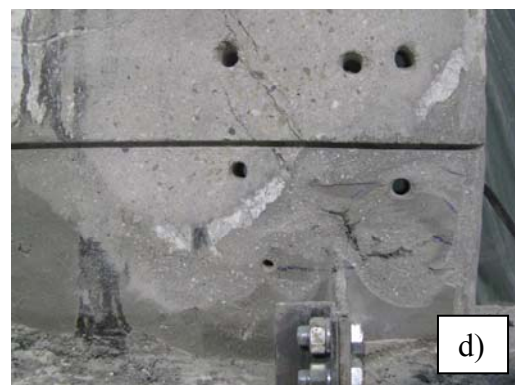
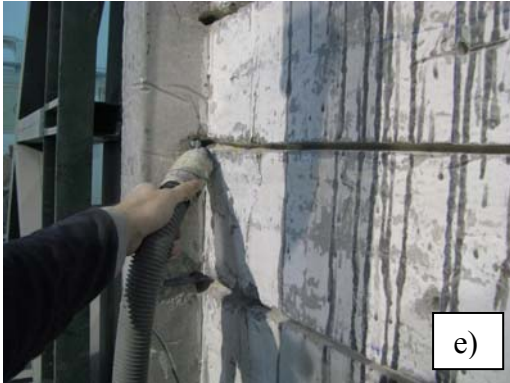
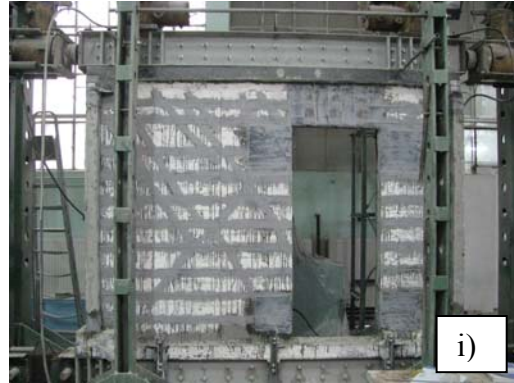
Fig. 3. The strengthening strategy

The damaged specimen was first repaired by removing the crushed concrete and replacing it with a high-strength repair mortar (Fig. 3a). The wall surface was then polished locally with a special grinder (Fig. 3b) to achieve a fully smooth surface for the externally bonding application, channels were cut for the CF plates (Fig. 3c), and the concrete edges of the element were rounded at a radius of approximately 20 mm to achieve the effectiveness of the confining solution. Local holes were drilled in the panel to provide the anchors for the confinement strengthening system (Fig. 3d), and the surface of the wall was vacuum-cleaned (Fig. 3e). The cracks were cleaned and filled superficially with epoxy resin.

According to the strengthening strategy, the NSM plates (Fig. 3f) (10 mm x 1.4 mm) were mounted horizontally in the piers and in the spandrel in each side of the wall at 200 mm centres (Fig. 3g). All CF plates were anchored in the wing element. CF confinement strips (Fig. 3h) were applied at the corners of the door opening and vertical, wrapping from one face to the other of the spandrel, and at the ends of the wing walls. The completed retrofitting is shown in Fig. 3i and 3j. Fig. (3k) shows the strain gauge position on FRP plates and fabric.

The failure of the post-damage strengthened specimen is presented in Fig. 3l, 3m and 3n.

During the experimental test of the post-damage strengthened specimen, namely PRCWP (12-E1-T/R), diagonal cracks appeared in the piers (Fig. 3l). Unfortunately, due to the capacity of the available testing facility, the specimen could not be taken to failure. The behaviour of the tested wall panel is shown in Fig. 4 as load-drift ratio response.

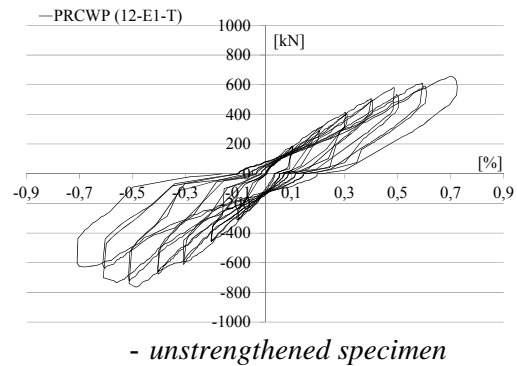
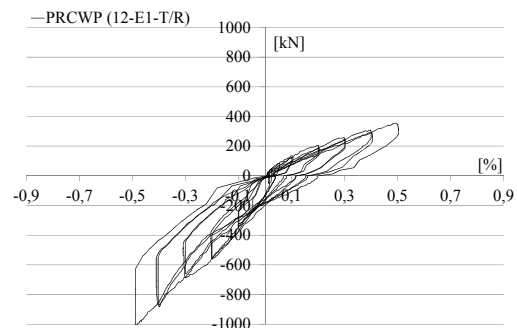
Fig. 4. Load-drift ratio response

The load bearing capacity results show a variation of 46.5 % in the positive loading cycles and 154 % in the negative loading cycles. It is obvious that the retrofitted element, namely PRCWP (12-E1-T/R) behaved highly superior compared to the reference one, PRCWP (12-E1-T).

- unstrengthened specimen

- strengthened specimen

The load bearing capacity of the specimen was increased through the retrofitting strategy, as confirmed by the load-drift ratio response of them. NSM-CFRP system can be an effective solution for strengthening elements. Further studies focused on numerical analysis, strengthening systems, openings in walls are in progress. The studies aims to establish the seismic performance of PRCWP under different parameters.
