INFRASTRUCTURE BEHAVIOR OF EXISTING STEEL BRIDGES IN OPERATION

Abstract: Estimating the carrying capacity of old steel bridges in mining, you need to take in consideration two things: the infrastructure and the superstructure. On the superstructure you can make some investigations, but the problem becomes more difficult when inspecting the infrastructure. This paper presents some typical solutions for the infrastructure of old metal bridges in operation

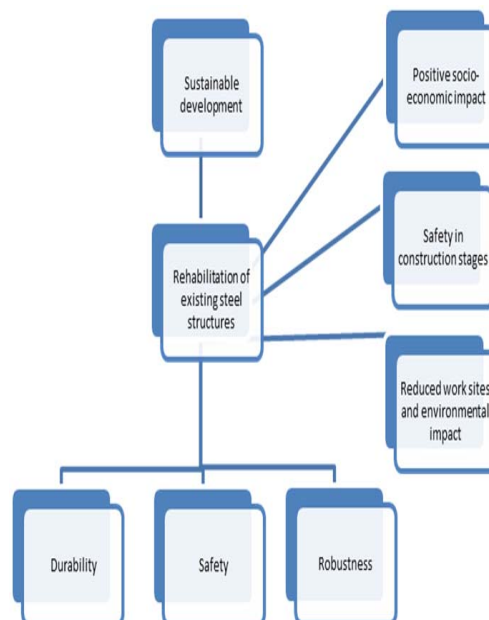
Fig. 1. Correlation schema for rehabilitation of existing structures

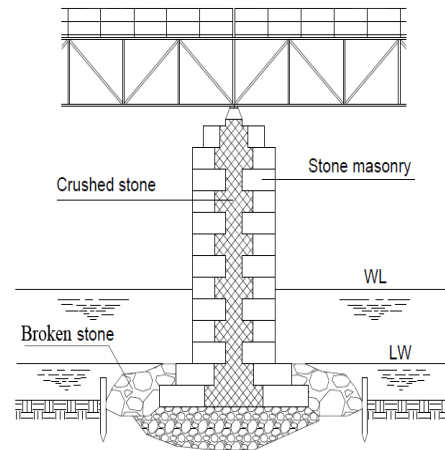
Fig.2 *Direct Foundation - pier*

Direct foundations were built on good soil for foundations, at reduced water levels or where there was the possibility of deviating the river course in order to realize it onshore. This solution was used for building light bridges with light loads (highway bridges). In general the bridge's piles were covered with stone masonry and inside they were filled with crushed stone or "ciclopian" concrete.

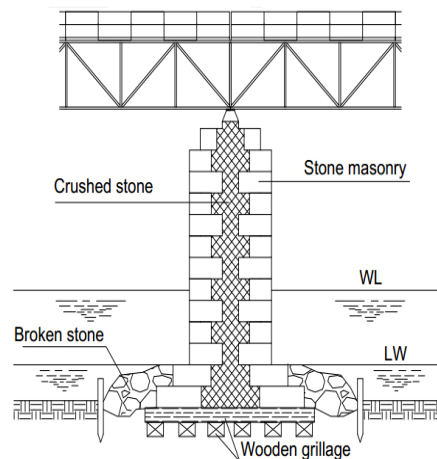
Fig.3 *Wooden grillage*

The same solution could also have a wooden beading material (grillage) in order to have a better repartition of the foundation ground.

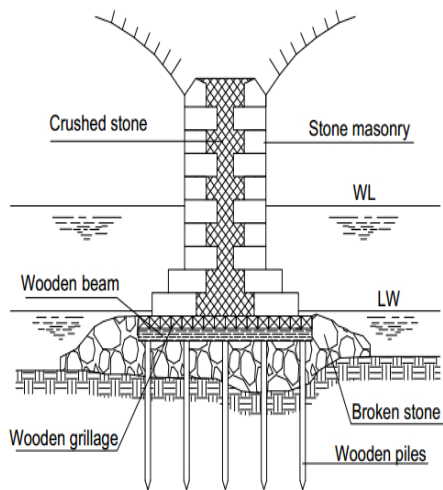
Fig.4 Wooden piles

The wooden piles were fitted in the ground at the right level with pile drivers. The top of the piles were covered with stones. Over the wooden piles, the structure was fitted with a surface made out of timber beams on which they continued building the stone masonry.

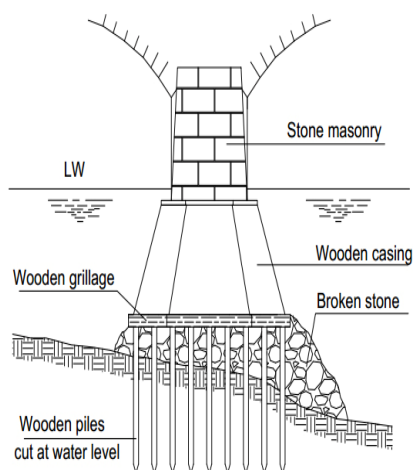
Fig. 5 Sunken wooden piles

A step forward was the solution with built-up wooden caissons, that was fitted

on top of the wooden beading material. The casing was set in the right position and then it was sunk. Afterwards, inside the caisson, the pile was built. After the work, the caisson was removed and used to build the next pile.

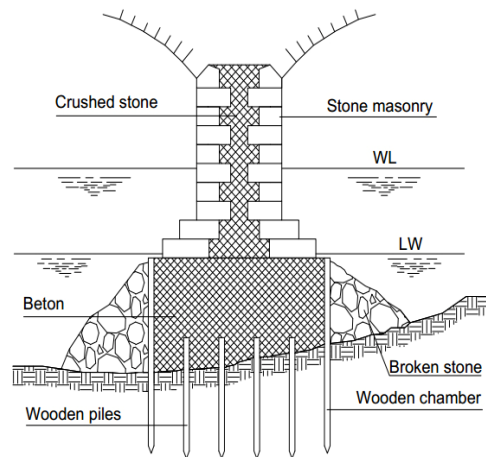
Fig.6 Wooden caisson

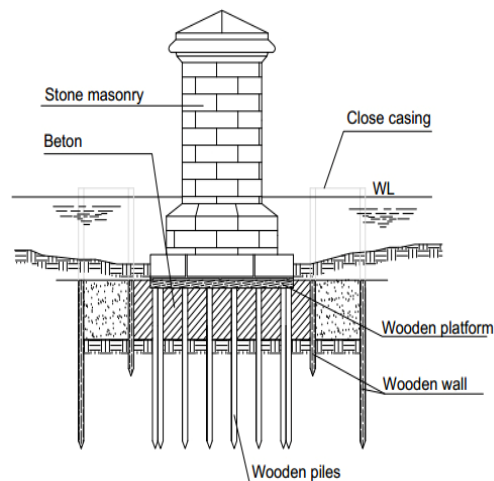
Fig.7 Double wooden sheet pile wall

Between timber walls, clay was put up in order to protect the pier. With the help of steam machineries, they dried the work-space in order to work on dry land.

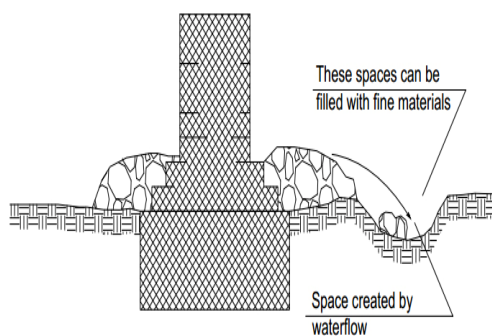
Fig.8 Scoring next to a pile

In the figure is presented the consequences of scoring next to a pile that is protected with embankment.(scoring next to a pile)

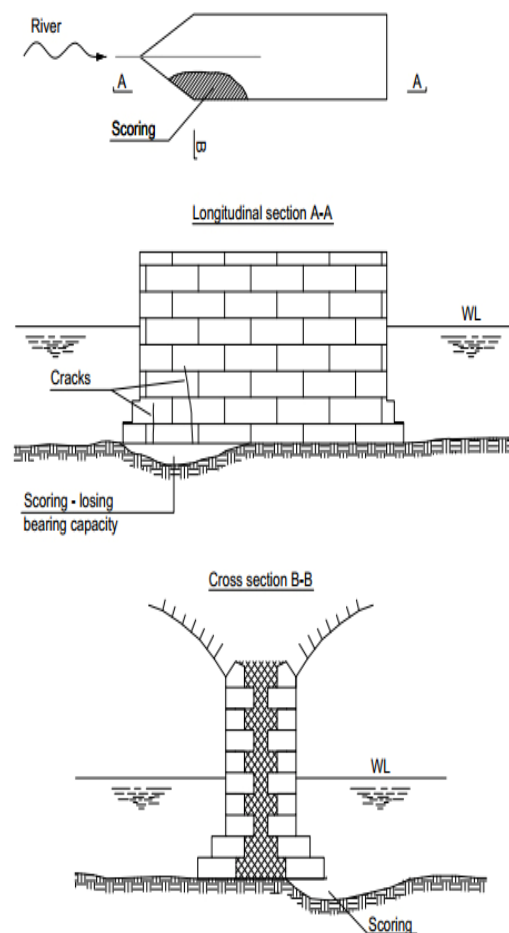
Another situation can occur to pile founded directly where scoring reduce the carrying surface of the foundation on the Foundation soil; in consequence cracks and settling may occur.

Fig.9 Scoring under the foundation

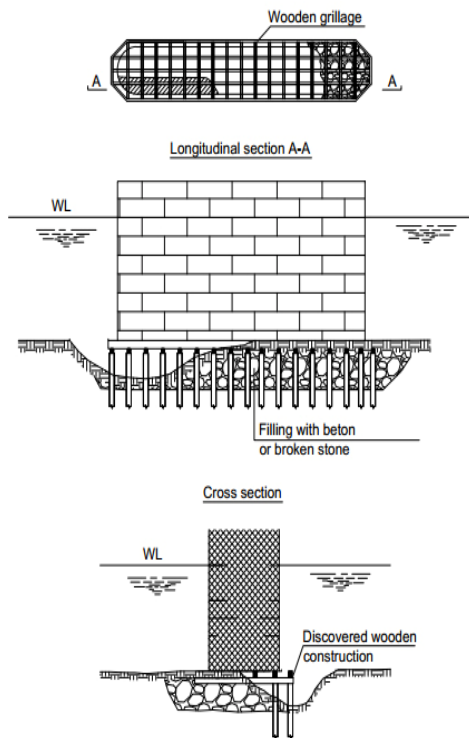
Fig.10 Sections

At foundations on piles scoring can lead to reducing their carrying capacity by reducing friction on the mantle, danger of buckling and pilots destroyed by the rot.

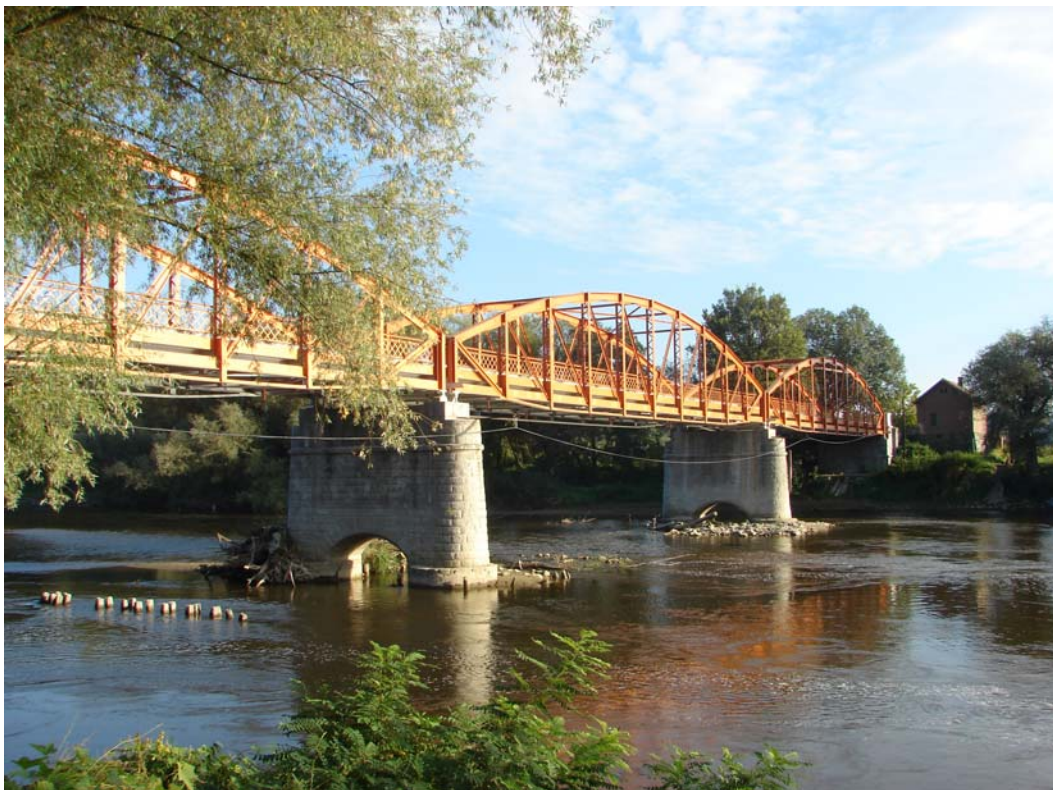
Fig.12 Savarsin Bridge after rehabilitation

The rehabilitation of the structure was realized with adequate solution without changing the general appearance of the structure. This project received the first European ECCS prize in 2010 [R.Băncilă, E.Petzek, D. Bolduș ” New life for an old historical steel bridge over the Mureș river” European Convention for Constructional Steelwork AWARD - First European prize, 2010 Sept.

A special problem was the rehabilitation of the infrastructure. Taking into account the general behavior of the structure, and carefully in situ observations (no

settlements or inclination were observed), only minor works to the abutments and piers were provided.
