The 4th International Conference
"Advanced Composite Materials Engineering"
COMAT 2012
18- 20 October 2012, Brasov, Romania

**THEORETICAL AND EXPERIMENTAL CONTRIBUTIONS
REGARDING INFRARED THERMOGRAPHY EXAMINATION OF
COMPOSITE MATERIALS USED IN CIVIL AND INDUSTRIAL
CONSTRUCTION**

This paper presents a method of non-contact examination by infrared thermography for the determination of such defects in beams, fittings and embedded pipes.

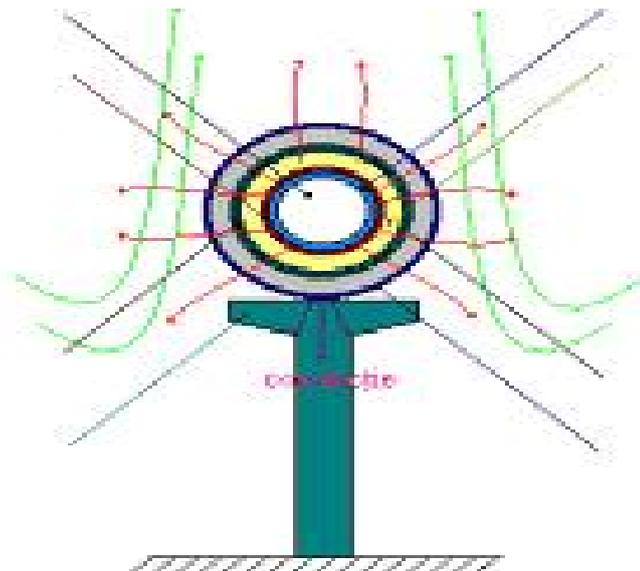
Figure 1 presents schematically a pipeline used to transport steam technology to an industrial building with an emphasis on forms of heat loss.

Figure 1: Heat loss in a steam pipeline technology.
