RECOVERING OF THE MECHANICAL PROPERTIES OF A PEHD PLATE CONTAINING A NOTCH BY THE GRINDING TECHNIQUE

Abstract : In this work, we present a repair approach of HDPE pipes. We use for this goal, a single Edge notched tension (SENT) samples with different notches lengths. We observe, in the first part, that the shapes of the force displacement curve change when the specimen contains a notch comparing to the tensile test of the plates without a notch and in the second part that the area value of the specimens decreases with the increase of the notch length. This area under the force-displacement curve represent the material deformation potential and the decrease of this energy indicate that the material loss his deformation potential in the presence of a notch. The aim of our contribution is to propose a rehabilitation method of the material deformation potential based on the mater removal around the notch by the grinding technique. We show that the recovering of the deformation potential of the material is possible by using this method. We, also, show that the mechanical properties of the material are better when the grinding well is bigger. To finish, we propose a recovering efficacy

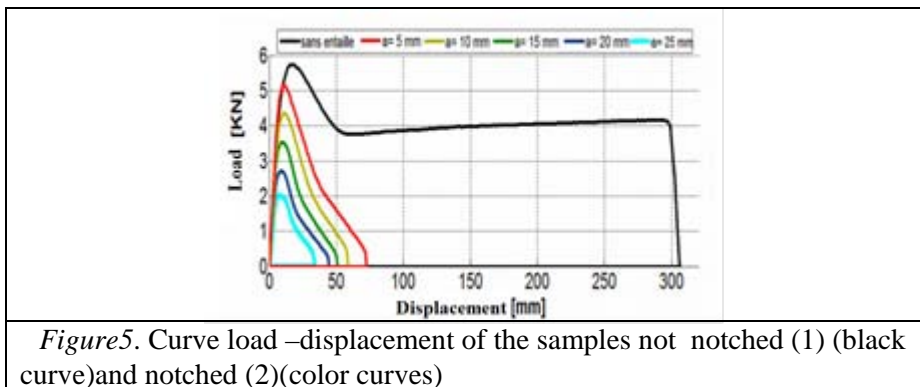
The notches carried out on the samples plainly change the material tensile behavior. We note that in the case of the virgin sample (see figure 5) we find the known behavior of the HDPE characterized by the succession of three stages which are:

- 1) The elastic phase with the thresholds of flow low and high;
- 2) The phase of flow elastic or viscoelastic;
- 3) The phase of hardening of material before its break off

In the case of the notched samples the viscoelastic phase disappears (see figure 5) and the elastic phase followed immediately the material break off. This indicating a great material embrittlement. This fact induces, also, a loss of a material deformation potential proportionally to the notch length.

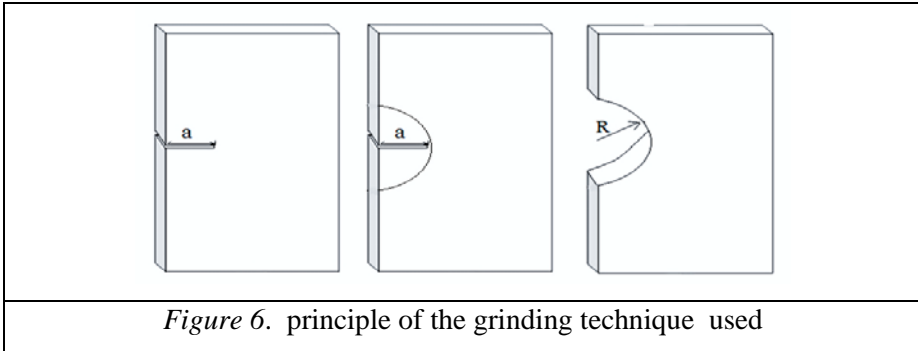
The material embrittlement observed previously is a problem and a proposed solution to avoid this situation is consisting on the total or partially recovering of the loss energy by rehabilitation or a repair technique. In our study we were inspired by the Eckstein [5] work who proposed a rehabilitation solution based on the removal of matter thanks to an operation of grinding of the cracked part (see figure 6).

The principle of rehabilitation is very simple; it acts to grind the cracked area thanks to a wheel. To optimize this repair we use several diameters of a grinding wheel so as to be able to reach repair optimal. After the matter removal, we carry out tensile tests on the repaired samples and we compare the tensile diagram of the notched sample with that of the repaired samples (see figures 7 and 8).

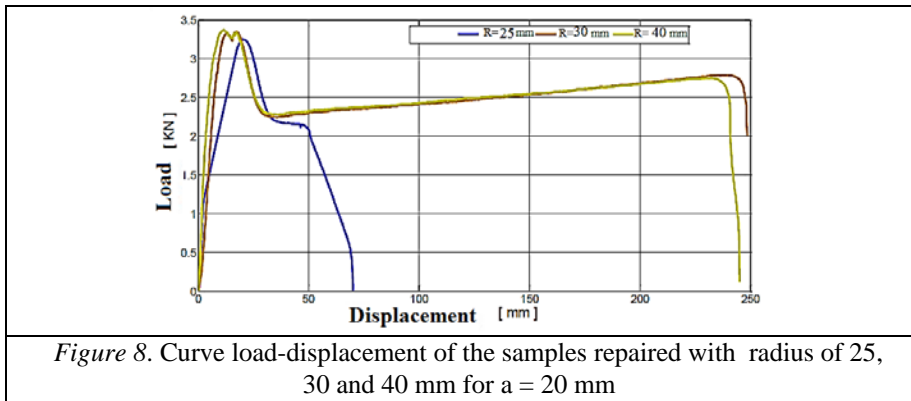
Figure 8. Curve load-displacement of the samples repaired with radius of 25, 30 and 40 mm for $a = 20$ mm

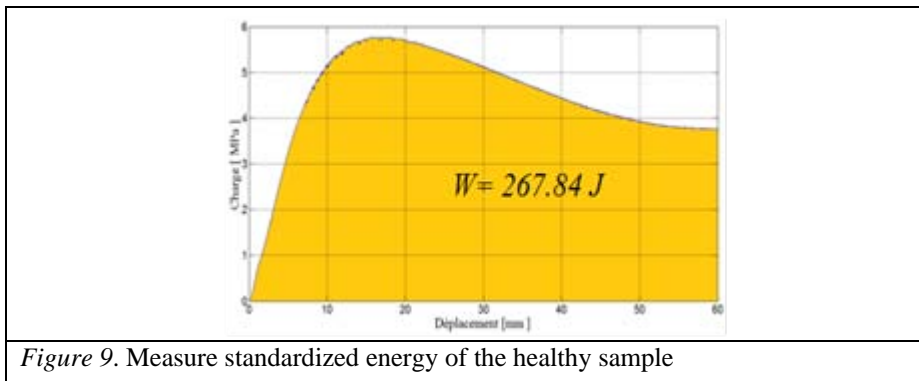
Figure 9. Measure standardized energy of the healthy sample

To account for the depth to which repair the notch could be effective we standardize all the values of energy of repair of the samples presented in table 1 at 60 mm of displacement, just at the necking end, we compare, then, the energy dissipated under the traction curve for the sample without notch (see figure 9) with the energy of the samples repaired, The results of these measurements are gathered in table 3:

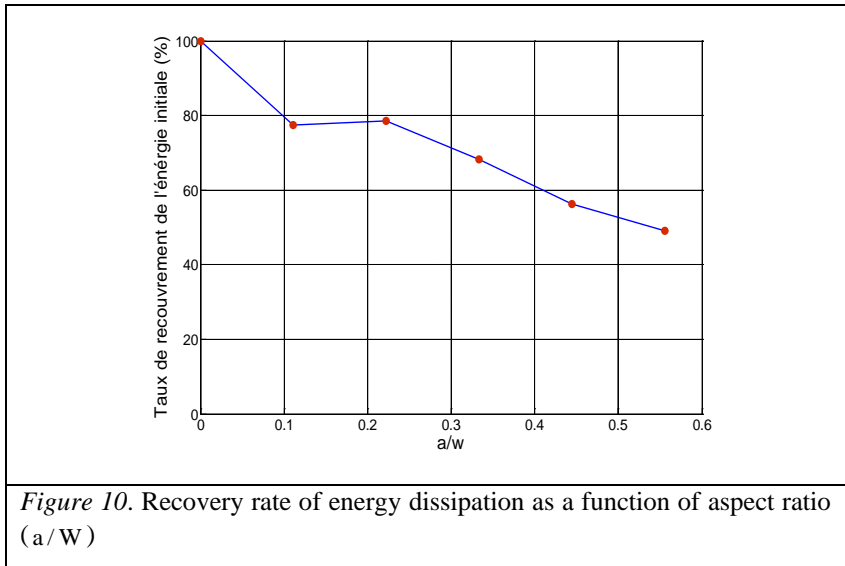
To find the optimal value of repair, we plot a graph connecting the fracture energies standardized to a geometrical parameter which is report/ratio length of notch a over the ligament length W (a/W) as represented on figure 10,

In Figure 10, we note that the fracture energy of the material decreases $W_m=267,84J$ corresponding to 100% of the energy is dissipated in the breakdown of the virgin sample $W_m= 207 J$ representing about 80 % for samples rehabilitated it then stabilizes between a (a/W) ratio ranging from 0.1 to 0.22 and then begin to decline until a rehabilitation rate of 50% of the energy dissipated. To optimize the repair we recommend a rehabilitation rate of energy dissipation of 80% which corresponds to an optimum aspect ratio $a/W=0,22$ beyond which the repair is not recommended and replacement of the section notched is recommended.
