5th International Conference
"Advanced Composite Materials Engineering"
COMAT 2014
16-17 OCTOBER 2014, Brasov, Romania

CRACKS AND MICROSTRUCTURAL CONSTITUENTS

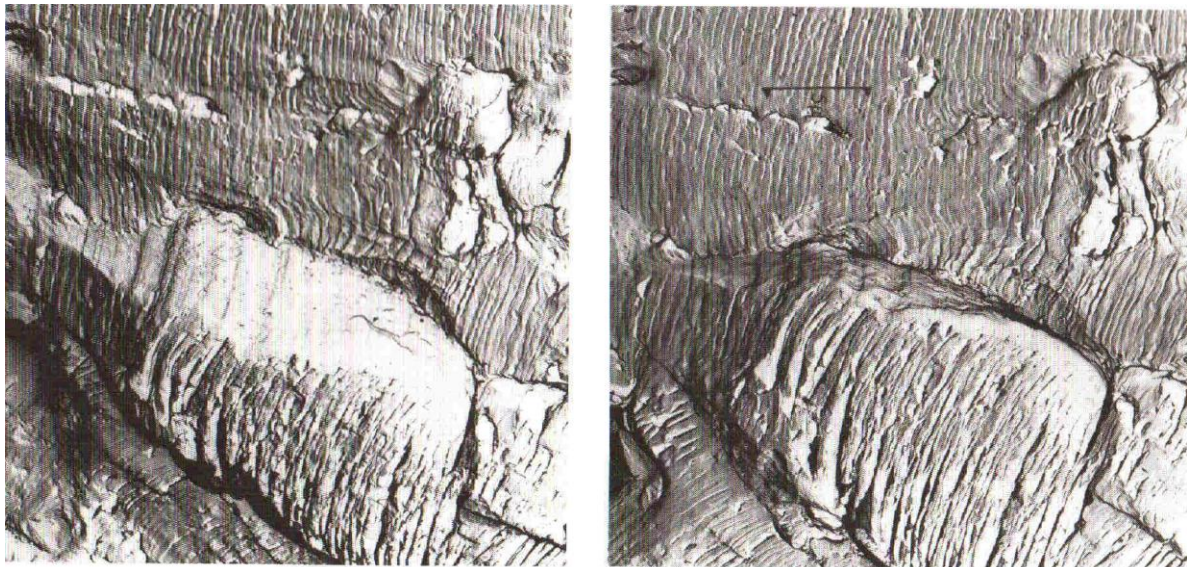
Figure 1a: A fatigue crack surface in Al-alloy

The present-day fatigue research is concentrated on materials cracks behavior, considering that such cracks are present to some degree in all mechanical structures. They may exist as basic defects in the constituent materials – assimilated to material deficiencies in the form of pre-existing flaws – or they may be induced in a certain engineering structure during the service life. In Fig. 1a a fatigue crack surface in Al-alloy has been represented. The whole life time of a certain structure subjected to fatigue cycles (or to static loads as well) depends upon the way in which material cracks do propagate until the final failure. In Fig. 1 and Fig. 2 two fatigue crack surfaces

have been represented. It is to be noted the direct influence of the fatigue crack propagation on the material grains structures. This is why the fatigue phenomenon gives a great importance to the interaction between the fatigue cracks and the microstructural constituents of the investigated alloy. A direct and an important consequence of such a position is that Miner's linear criterion of damage mechanics loses its validity.

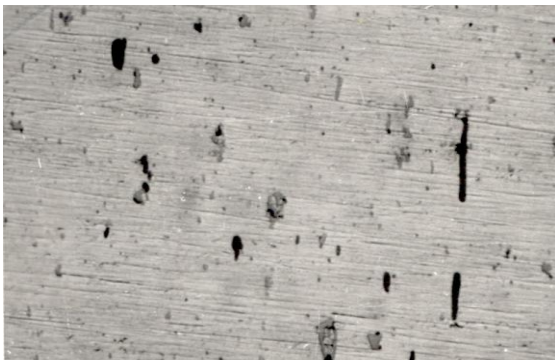
Figure 4: Microstructure of Al 6061 T651 (x300)

In Fig. 4 and Fig. 5 the structures of the considered aluminium alloy, before subjected to fatigue cycles have been represented. In Fig. 6 different types of fatigue cracks interacting the microstructural constituents of the investigated aluminium alloy have been presented. For a small number of fatigue cycles the cracks produced may be very fine and short ($\sim 0.04-0.07$ mm) - propagating along a single direction (Fig.6 a,b) or may be short and rough, with a bifurcation at end (Fig.6c). One may also notice that in Fig. 6a the crack stopped in its interaction with an above presented chemical compound. There are also cracks which are fine but long (0.1-0.3 mm) that usually propagate at the level of inter-granular area, following the grains borders and passing through the fine precipitated compounds or rounding the components.

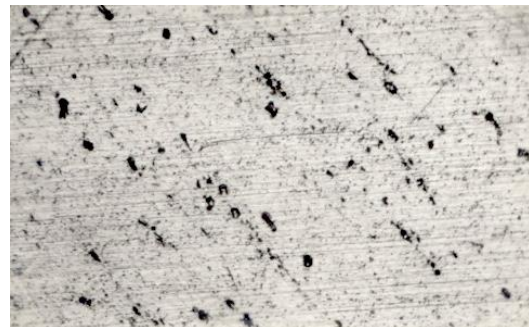
Figure 5: Microstructure of Al 6061 T651 (x300)

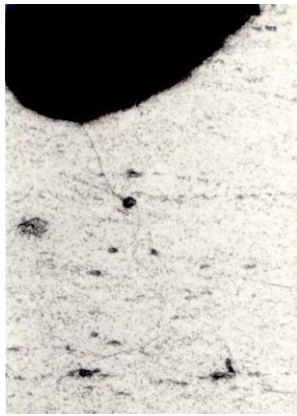
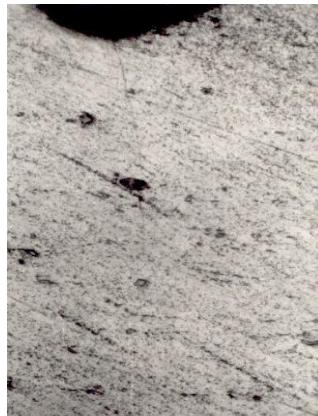
Figure 6: Mechanical interaction between fatigue cracks and microstructural constituents
